**Large-Scale Testing and Numerical Simulations of Composite Floor
Slabs Under Progressive Collapse Scenarios**

Dissertation

The University of Texas at Austin

May 2015

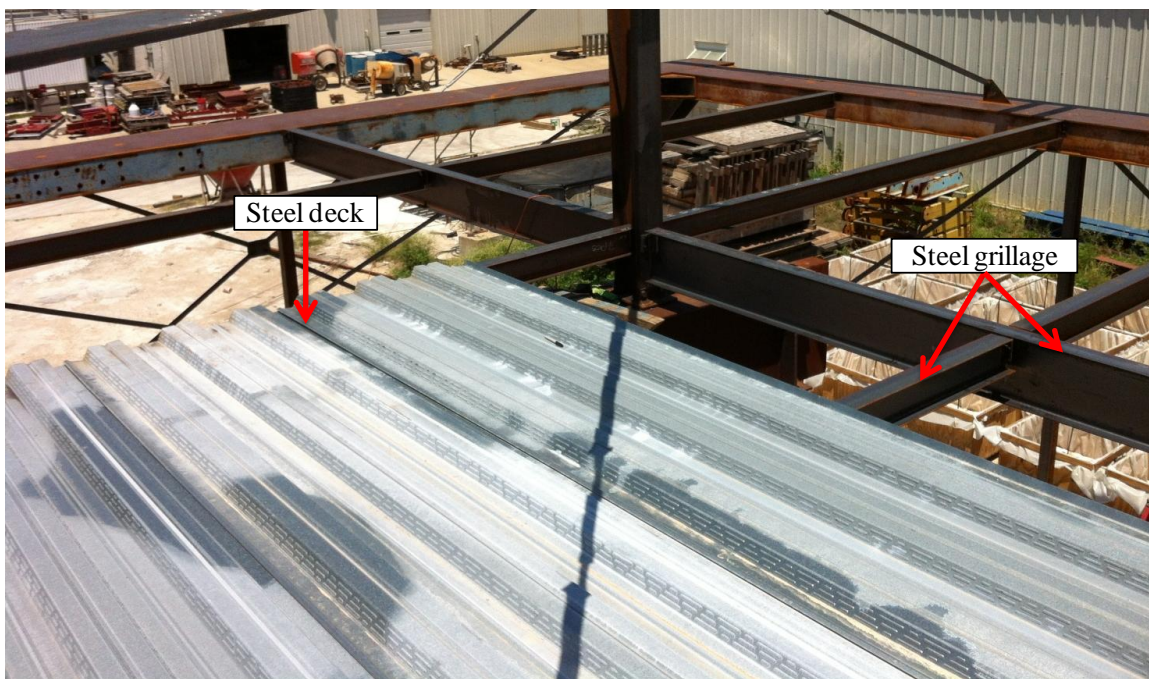
Figure 1.2: Placement of the steel deck over the steel grillage

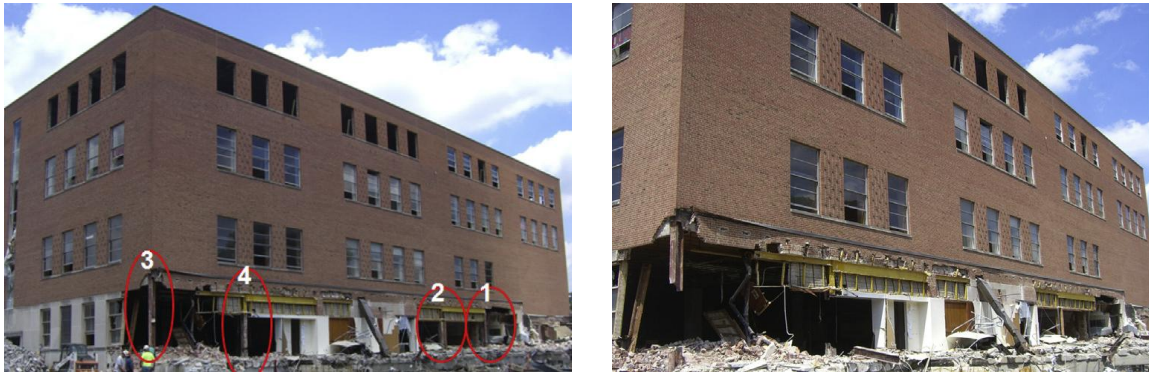
Figure 2.1: Removal of four exterior columns in a steel-frame building (Song and Sezen 2013): (a) before, (b) after

structural components was present at the time of testing. Figure 2.1 shows the condition of one of the test buildings before and after the removal of four exterior columns (Song and Sezen 2013). The buildings in this study demonstrated excellent resiliency because they were able to sustain the column removals. Nonetheless, further analysis identifying critical factors contributing to the response have not been performed.

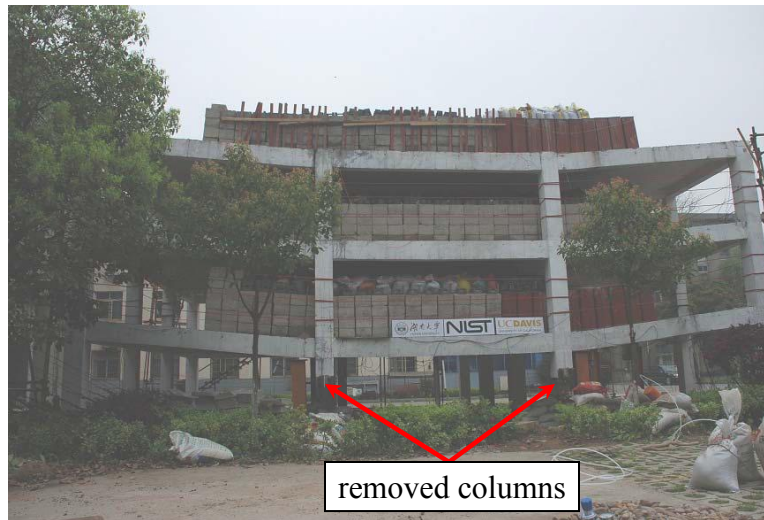
Figure 2.2: RC frame structure under a series of column removal scenarios (Xiao, *et al.* 2013): (a) Plan view, (b) Failure of the structure following the removal of two exterior columns

removed. The structure successfully sustained the instantaneous removal of the columns of Test 1 and Test 3. In Test 2, when the two side columns along the long side of the structure were removed, the deformations increased considerably, and the frame was falling in a free fall form. It eventually collapsed on a steel shoring column. The steel shoring column was placed at the ground floor, a few feet below the slab level to prevent collapse of the frame and allow more tests. The lack of lateral restraint from the adjacent corner columns did not allow the beams framing into the removed columns to develop catenary action. Although the structure did not collapse due to the presence of the steel shoring column, it is speculated that collapse would occur if the shoring support was not present. This test demonstrates the importance of lateral restraint that the intact portions of a structure must provide for the development of catenary action, which is important in redistributing loads to adjacent bays. The gravity loads on these tests were sufficient to demonstrate some of the limit states associated with column removal scenarios, something that the in-situ tests failed to demonstrate due to the lack of any superimposed gravity loads on the buildings.

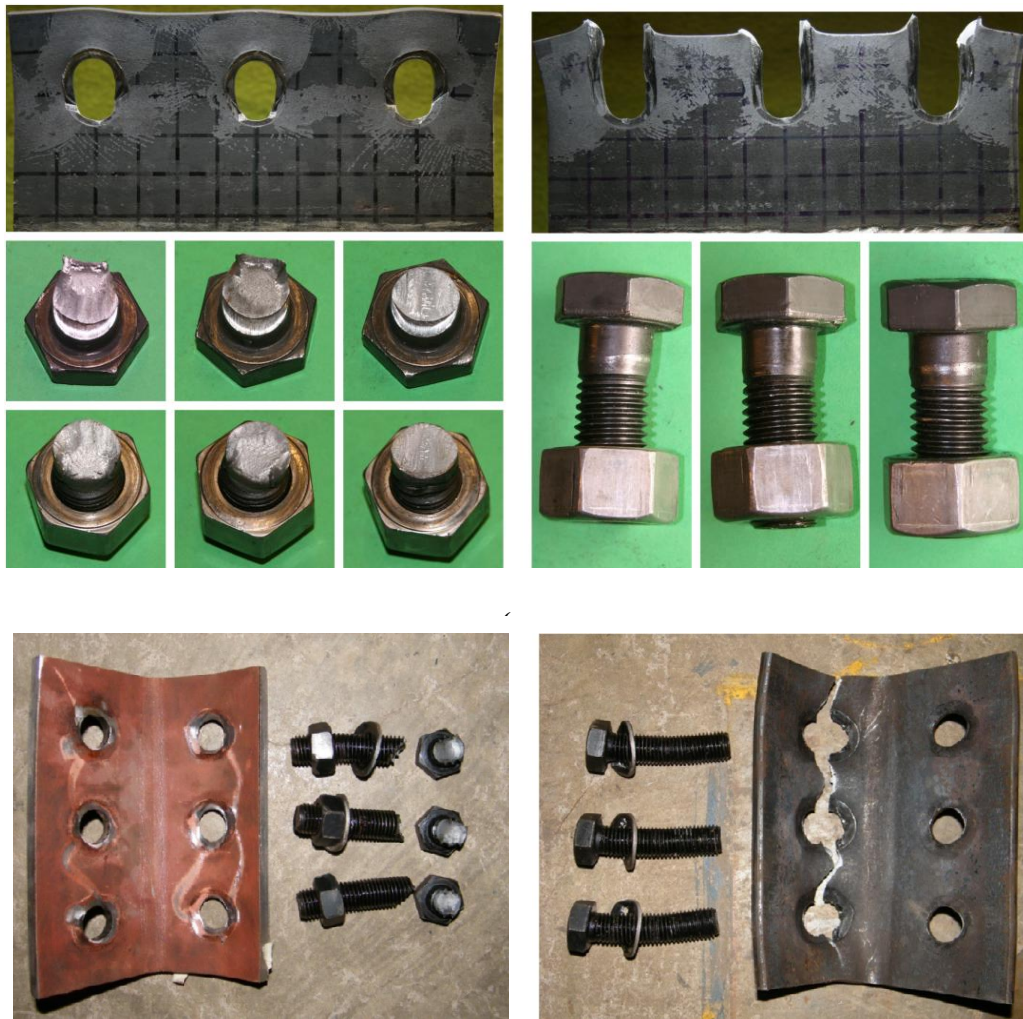
Figure 2.7: Failure modes observed in simple shear connections under tensile loads: (a) Single plate shear connection (Weigand and Berman 2013), (b) Double angle shear connection (Yang and Tan 2013)

demonstrate that their ability to resist progressive collapse is questionable. Weigand and Berman (2013) performed a series of tests on single plate shear connections extracted from a prototypical steel-framed building. The connections were loaded under combinations of tensile and shear force aiming to characterize their response under column removal scenarios. Analyses of the experimental results showed that the connections did not have adequate capacity to carry the specified design shear strength. The authors suggested that the resistance of the composite floor slab, present in an actual building configuration, might be essential to resisting collapse. In a related project, Yang and Tan (2013) performed a series of tests on double-angle shear connections to characterize their response under tensile loads. Similar failure modes were observed in both test programs, as shown in Figure 2.7.

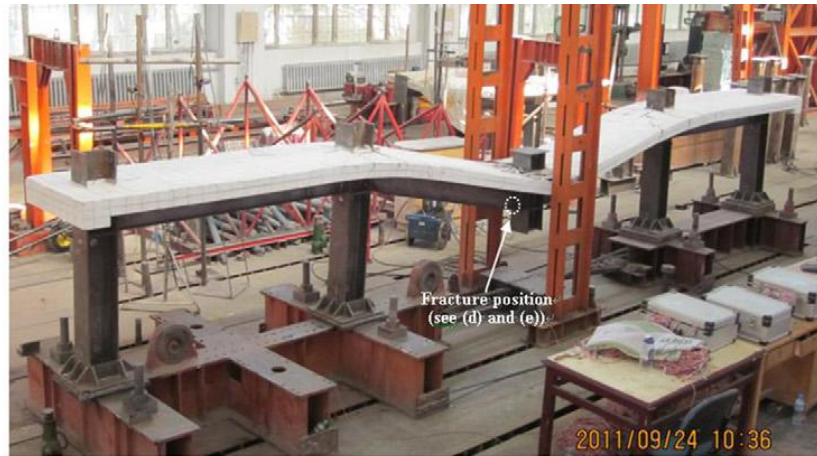
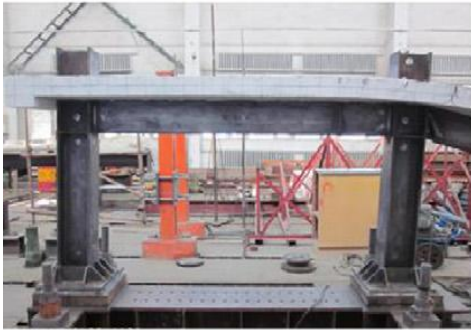
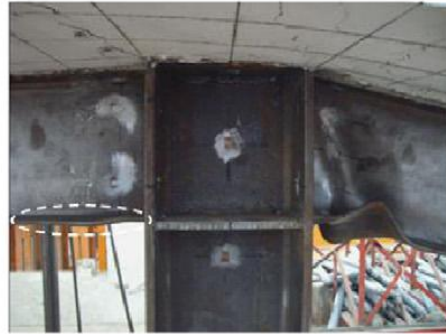
Figure 2.9: Failure modes in composite moment frame under middle column loss scenario (Guo, *et al.* 2013): (a) Overall condition of the specimen after the test, (b) Localized beam buckling, (c) Bottom flange and web fracture

modes between moment and simple connections further supports this argument. As shown in Figure 2.8 and Figure 2.9, failure in moment-resisting connections under a simulated middle column removal scenario is usually due to fracture of the beam section adjacent to the connection. On the contrary, under similar loading conditions, failure modes in simple connections, shown in Figure 2.7, occur within the connection components and are associated with bolt fracture or fracture of the connection plates or angles.

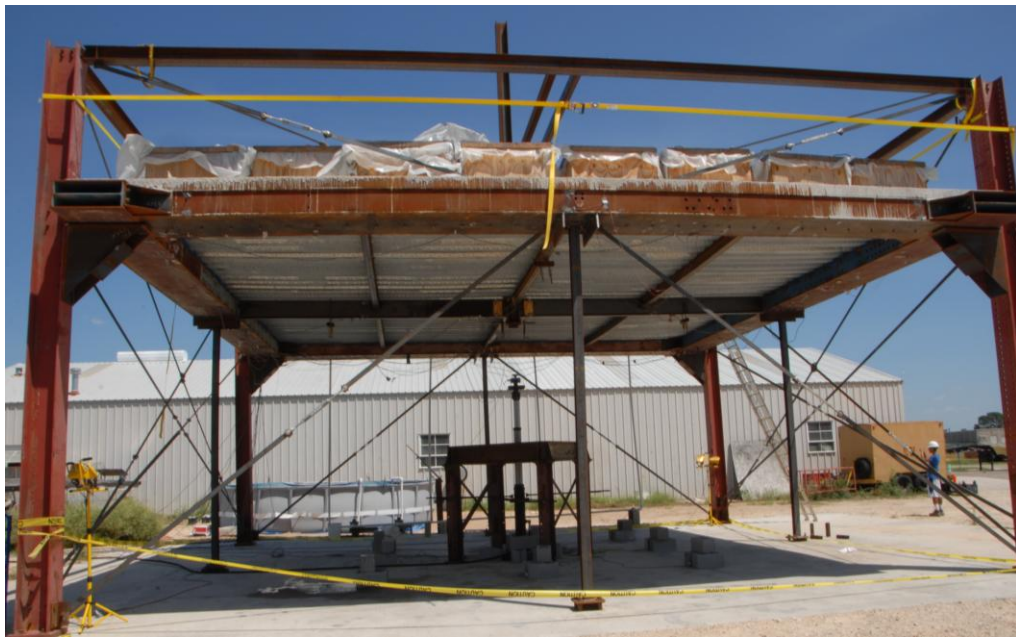
Figure 3.16: ICL specimen after the removal of the mid-span support

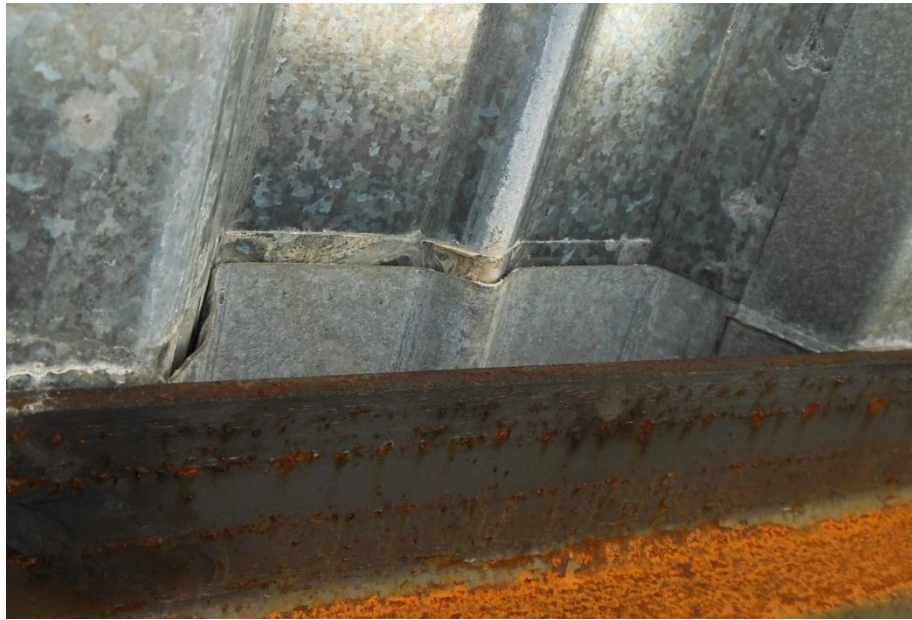
Figure 3.17: Relative slip of the corrugated steel deck panels parallel to the longitudinal lap

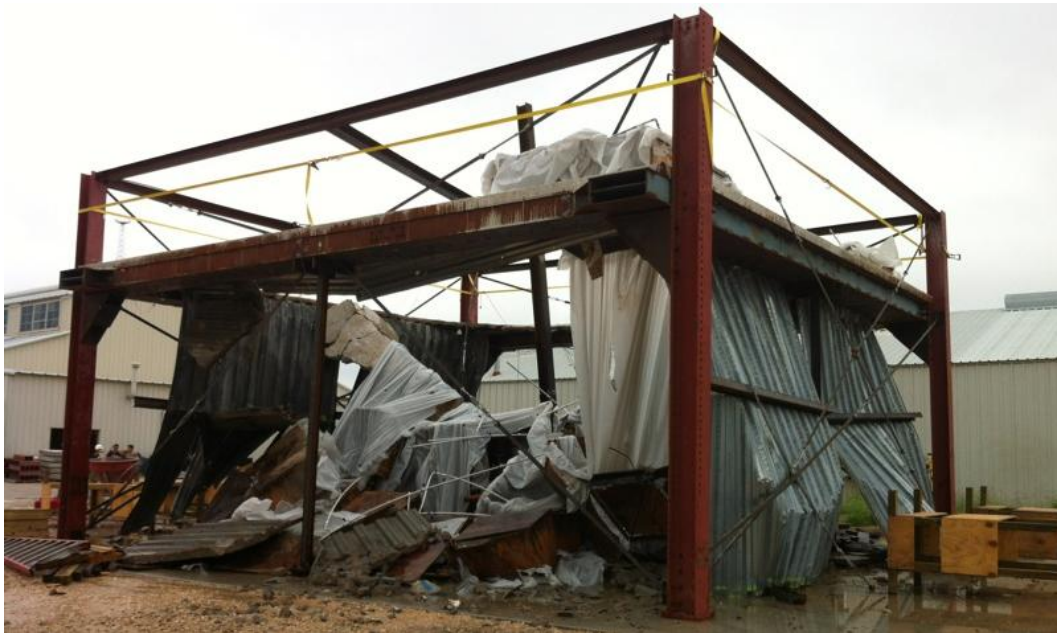
Figure 3.19: ICL specimen after collapse

Figure 3.18 shows a series of snapshots from the video footage of the specimen while collapsing, and Figure 3.19 shows the post-collapse condition of the specimen.

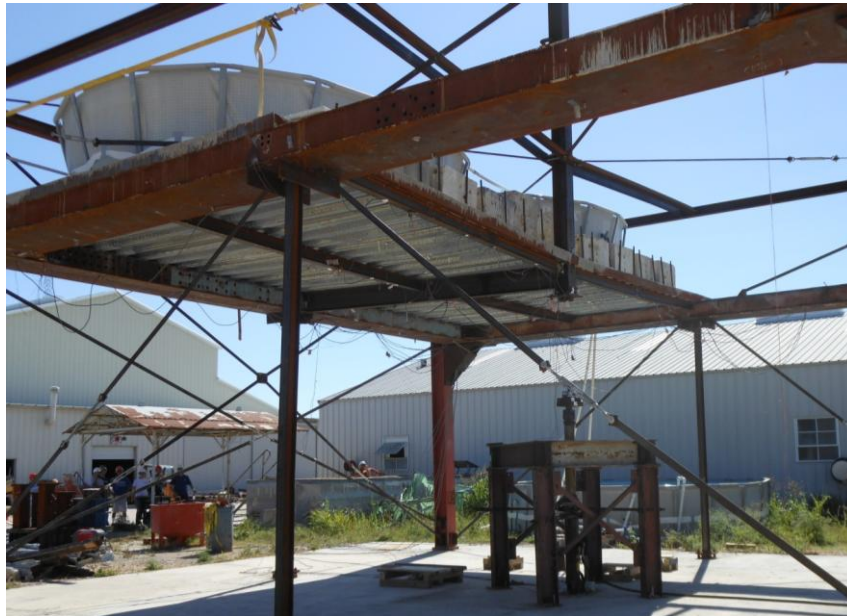
Figure 3.22: ECL specimen after the removal of the mid-span support

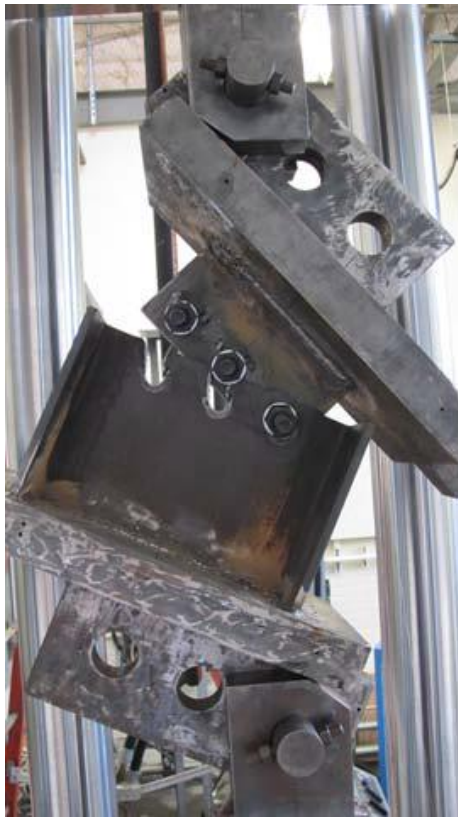
Figure 4.22: Comparison of connection failures for axial tension: (a) Test, (b) LS-DYNA

Figure 4.22 and Figure 4.23 show a comparison between the failure modes observed in the tests and those predicted from the computational analyses. The failure modes are quite similar, and the bearing failure in the beam web is captured in both cases. Further, no significant plastic deformations are developed in the bolts or the shear tab plate. These observations provide confidence that this modeling approach is suitable for progressive collapse analyses, because such failure modes are likely to be observed under the extreme loading conditions associated with column removal scenarios.

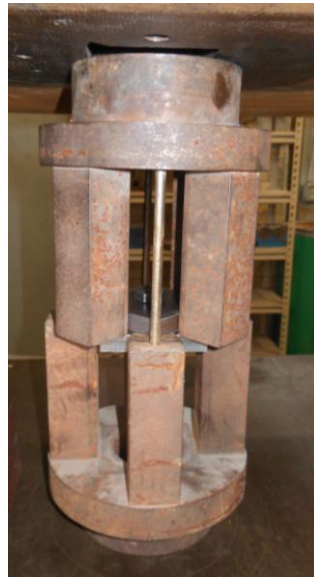
Figure 4.43: Testing device for bolt tensile strength

All bolts used for both specimens were 12.7-mm in diameter. During the tests, the bolts were primarily loaded in tension. Thus, tension tests on these bolts were performed using the setup shown in Figure 4.43. The obtained load versus displacement curve from the bolt tension tests was used to guide the selection of material parameters used in the constitutive model for the bolts. A bolt with nominal specified dimensions equal to the one used in the specimens was modeled and loaded in tension in LS-DYNA, as shown in Figure 4.44. The threads of the bolt were not included in the model, and the bolt-shaft was modeled as a cylinder. A number of other important details that influence the computed response were included. The diameter of the modeled bolt was based on the net area of a 12.7-mm diameter bolt that was found according to Kulak, *et al.* (2001). The diameter corresponding to its net area was 10.95-mm (Figure 4.44). The gauge length of the bolt (i.e., the length between the bolt head and the nut) was nearly identical to the one used in the tension tests of the bolts. It is noted that the bolt gauge lengths varied for different locations within the steel grillage because they were used to connect components of different thicknesses. A length of 21-mm (Figure 4.44) was representative

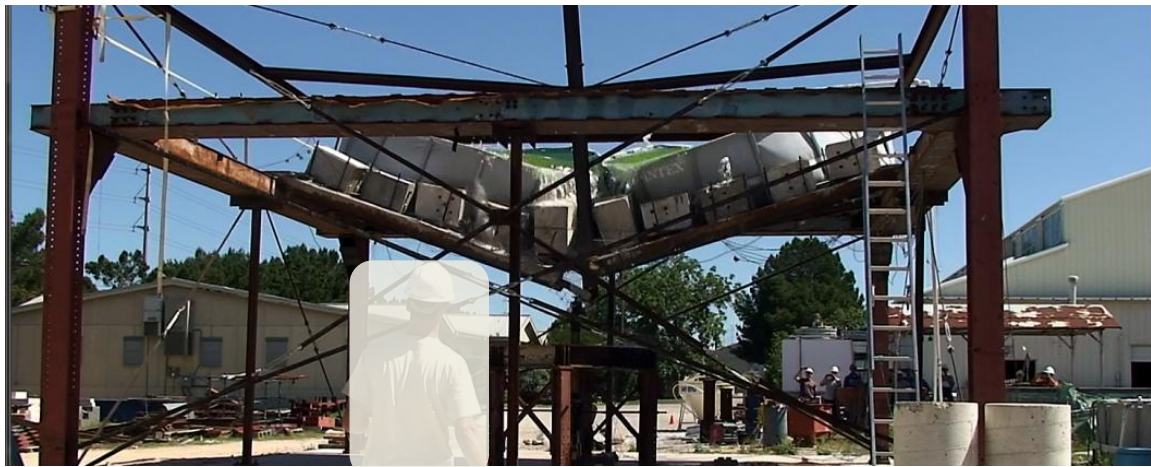
Figure 4.58: ECL Specimen during collapse, north view, (a) Experimental test, (b) FE simulation

Figure 4.58(a) shows a snapshot of video footage taken during collapse, and Figure 4.58(b) is a picture from the FE simulation at approximately the same state of collapse. Globally, comparing the two parts of the figure, the deflected shape and condition of the slab are in good agreement. Figure 4.59 shows the condition of the specimen during collapse from a different point of view. Again, it can be seen that the observed and predicted responses are quite similar. The separation of the steel decking because of failure at the side-lap is depicted in this figure, which is also captured in the FE simulation.

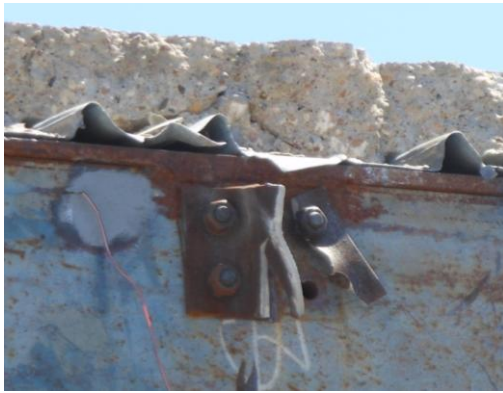
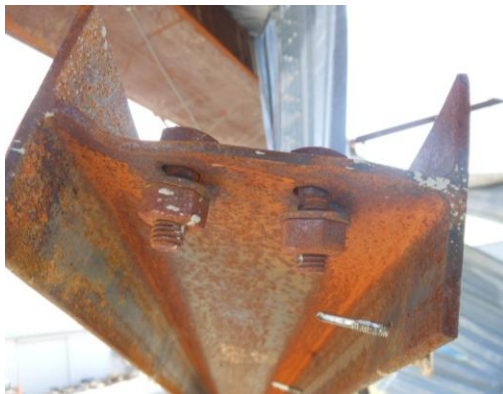
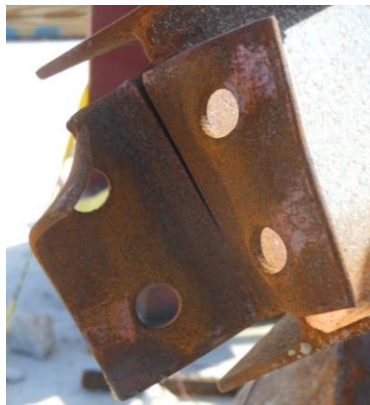
Figure 4.61: Comparison of post-collapse condition of ECL specimen with LS-DYNA analysis, (a) Double angle connection, (b) Shear tab connection, (c) Double angle connection (refer to previous figure)

In Figure 4.60, certain locations of the ECL specimen are depicted, and failure modes at these locations are compared with those from the FE simulations. Figure 4.61 provides a set of pictures for each one of these locations for comparison of their post-collapse condition. Figure 4.61(a) shows the post-collapse condition of the double angle connection of the main girder to perimeter beam connection. The failure modes of the test specimen and the FE model compare quite well; in both cases, the bolts did not fracture

because failure occurred in the other leg of the angle section, which was welded to the girder web. The condition of the shear tab connection between the secondary floor-beam to the perimeter beam is shown Figure 4.61(b). The shear tab plate fractured (not shown in the picture), while the two bolts remained intact. This response was also captured with the FE analyses. Contrary to the other double angle connection shown in Figure 4.61(a), the failure mode of the double angle connection of the floor beam to the perimeter beam was different, as shown in Figure 4.61(c). In this case, the bolts fractured while the angle sections remained intact, which is in agreement with the FE analyses. The residual plastic deformations that can be observed in the actual section are speculated to occur because of the falling debris during collapse and are not directly associated with the failure mode that caused the connection to fail.
